GMCA427

2011-2015 CHEVROLET/GMC,
SILVERADO/ SIERRA, HD2500-3500,
DURAMAX, DOWN PIPE
CARB EO# D-763-2

MBRP®

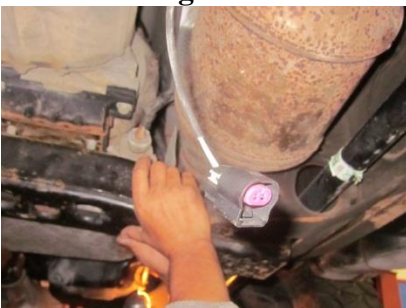
Figure 10

6. Reinstall the passenger side inner fender.
7. Reinstall the turbo heat shield. **Refer to Figure 10.** Check along the exhaust to make sure all connections and tightened. Check along the whole length of the exhaust system to ensure that there is adequate clearance around the spare tire, fuel and brake lines or any wiring. If any interference is detected relocate or adjust.
