# ***ALTERUM***

## **LEATHER CENTER CONSOLE COVER**

(2007-2013 SILVERADO/SIERRA)

### INSTALLATION INSTRUCTIONS

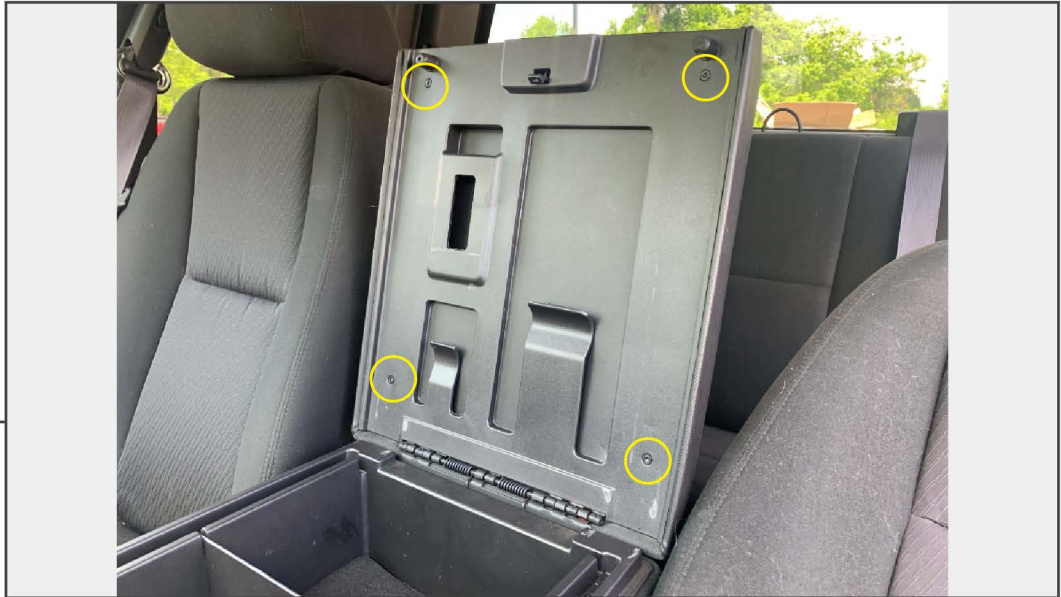
## STEP 1

Open the center console lid. Remove (4) T-20 Torx screws from the plastic panel on the lid.

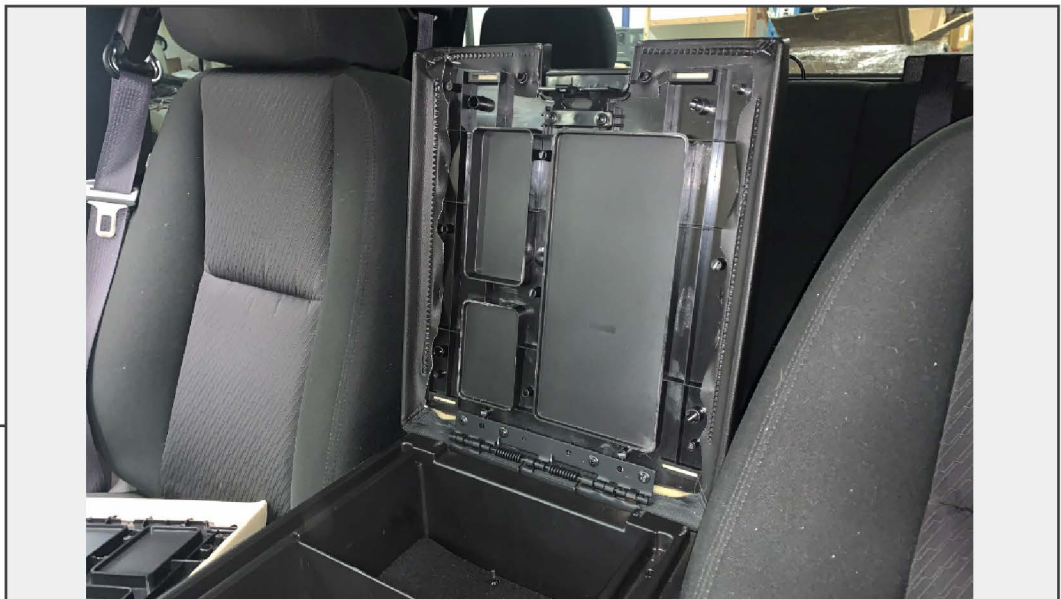
## STEP 2

Using a plastic panel pry tool, remove the plastic panel from the center console lid.

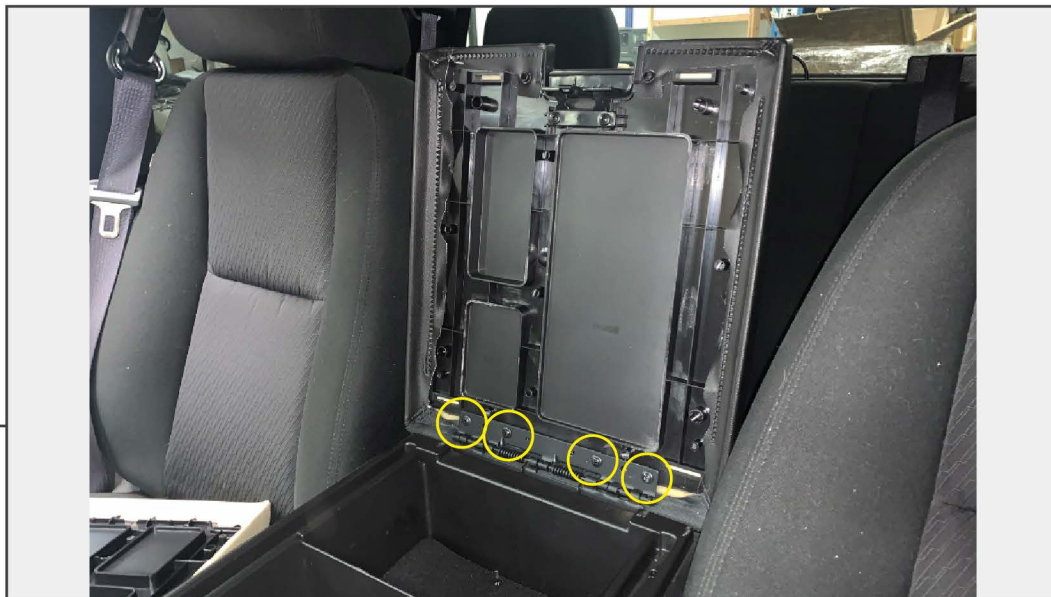
## STEP 3

Remove (4) Phillips screws from the hinge going through the center console lid. Remove the lid from the vehicle.

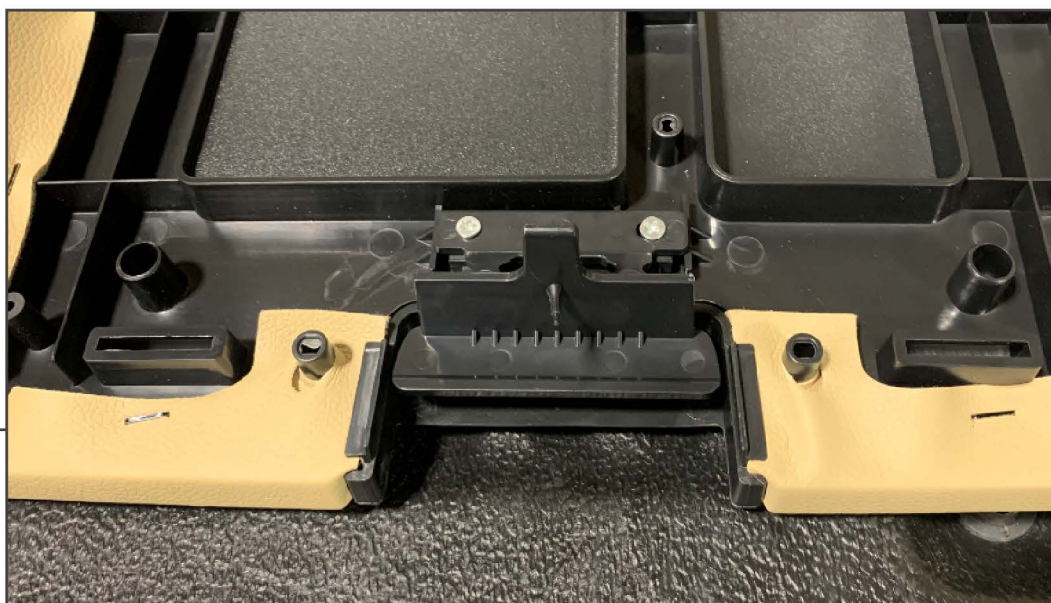
## STEP 4

Remove the (2) pre-installed Phillips screws in the new center console lid, then install the provided center console latch into the lid. Tighten the screws until secure, do not over tighten.

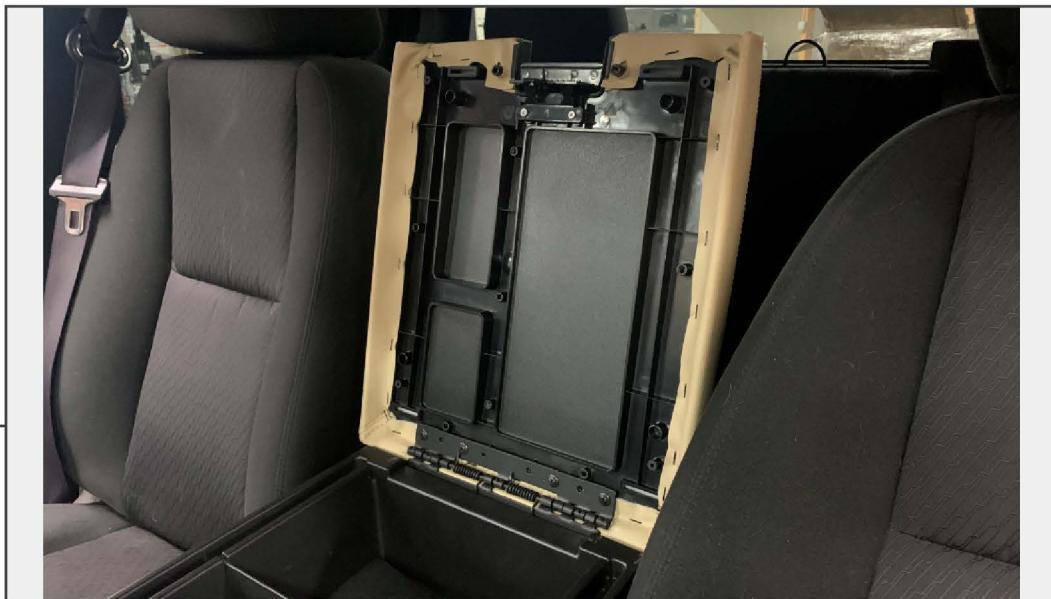
## STEP 5

Install the new center console lid to the vehicle re-using the original (4) Phillips head screws. Tighten until secure, do not over-tighten.

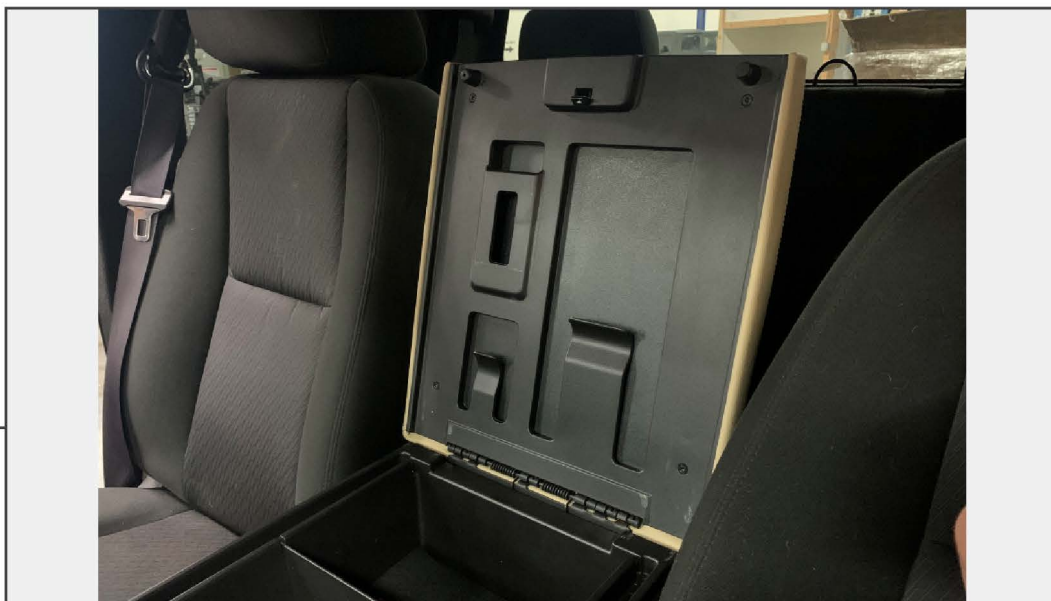
## STEP 6

Install the original plastic panel to the new center console lid re-using the original (4) T-20 Torx screws. Tighten until secure, do not over-tighten.

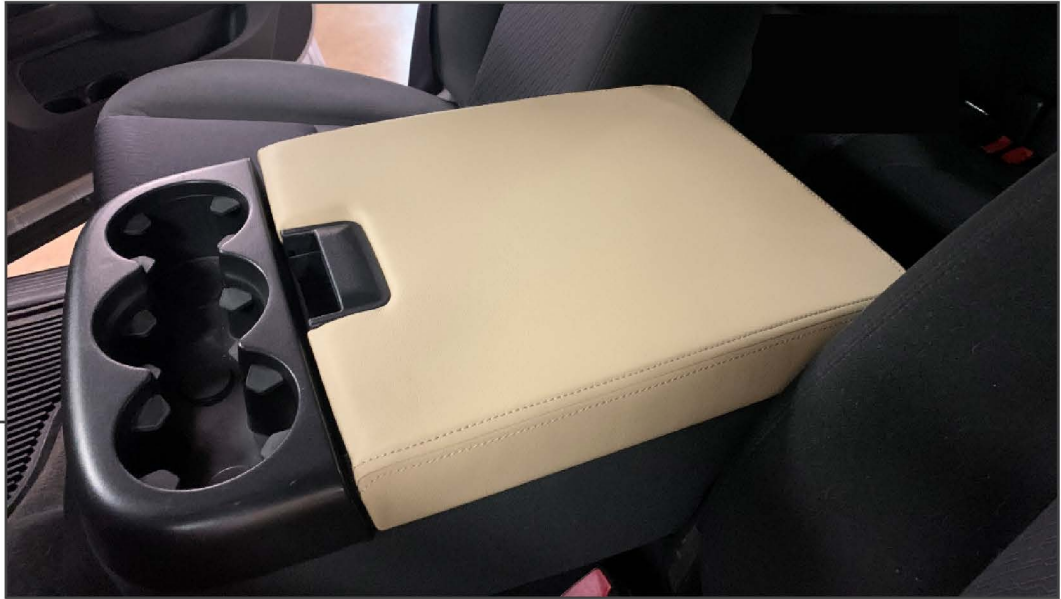
## **STEP 7**

Close center console lid and ensure latch functions normally.
