TUBULAR UPPER CONTROL ARMS

(2019-2022 SILVERADO 1500)

INSTALLATION INSTRUCTIONS

SKU # S196074

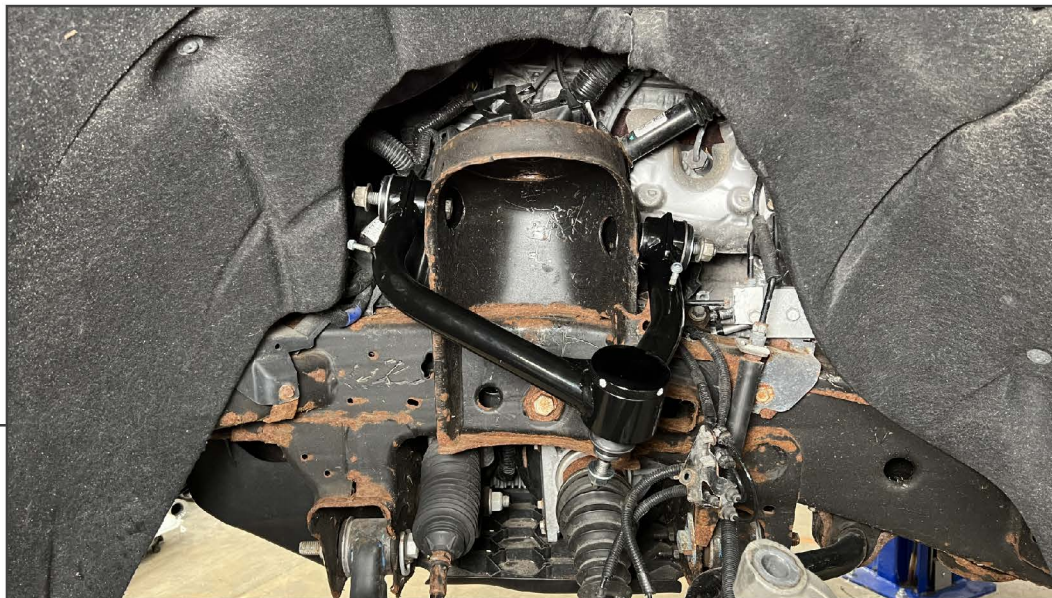
STEP 7

Fit the new control arm to the vehicle using the original control arm hardware. Do not fully tighten the hardware at this time. The control arm mounting bolts will be tightened with the vehicle on the ground with the suspension loaded.

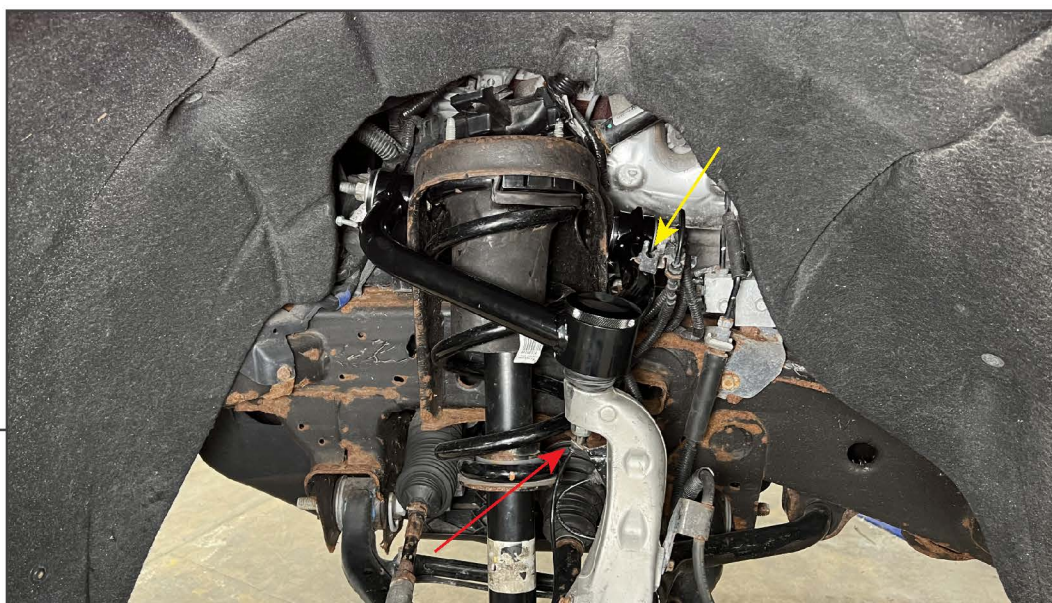
STEP 8

Re-assemble the vehicle suspension components following steps 1-5 in reverse order.

Secure the upper control arm ball joint to the steering knuckle using the included (1) 18mm lock nut. Secure the brake line bracket to the control arm using the (1) M6 lock nut.

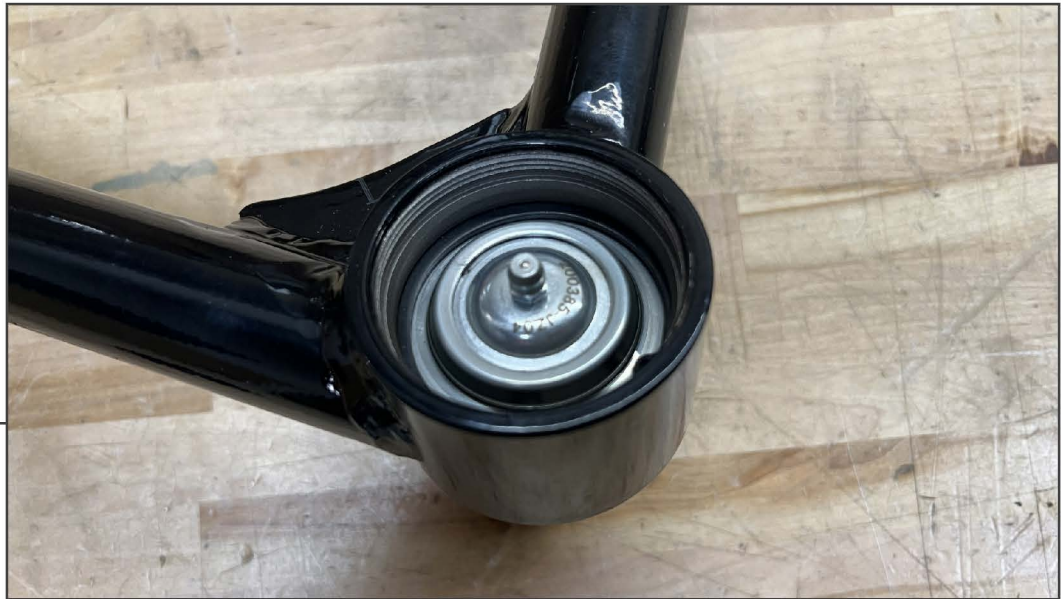
STEP 9

Turn the ball joint cap counter-clockwise to remove the ball joint cap to reveal the grease fitting. Fill the ball joint with synthetic grease until full, do not overfill.

With the ball joint greased, re-install the cap.

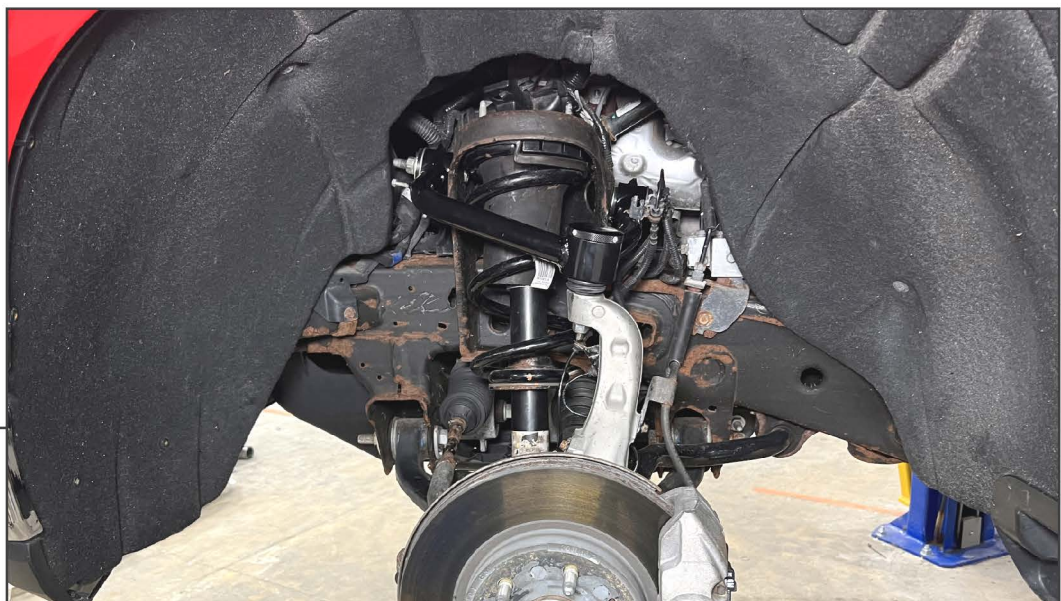
STEP 10

With the vehicle suspension loaded, torque the upper control arm bolts evenly to 90 ft. lbs.
