BD Diesel Valve Body

For GMC/Chevrolet Duramax 6.6L Trucks

1030470	2001-04 Duramax (LB7)
1030471	2004-05 Duramax (LLY)
1030472	2006-07 Duramax (LBZ)
1030473	2007-10 Duramax (LMM)

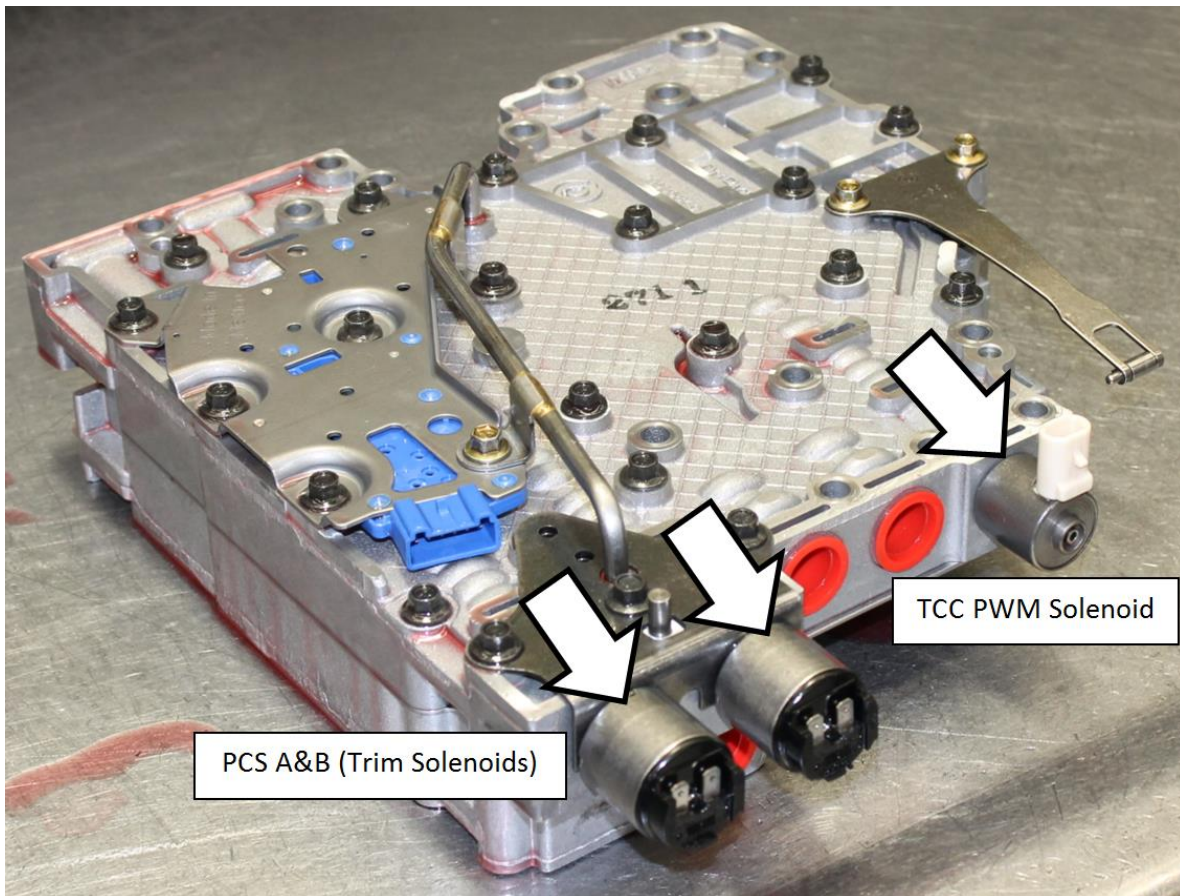
- Remove the BD Allison Valve Body from the packaging and ensure the manual valve and pin are present (usually in a separate bag at the bottom of the packaging foam).
- The BD Allison Valve Body is supplied with the more critical solenoids which have been tested in our facility during assembly. The customers original solenoids must be returned with their core for full credit.
- **1030470** – 2001-2003 Allison valve bodies are supplied with three solenoids. Pressure Control A (TRIM A), Pressure Control B (TRIM B) and the TCC PWM Solenoid.

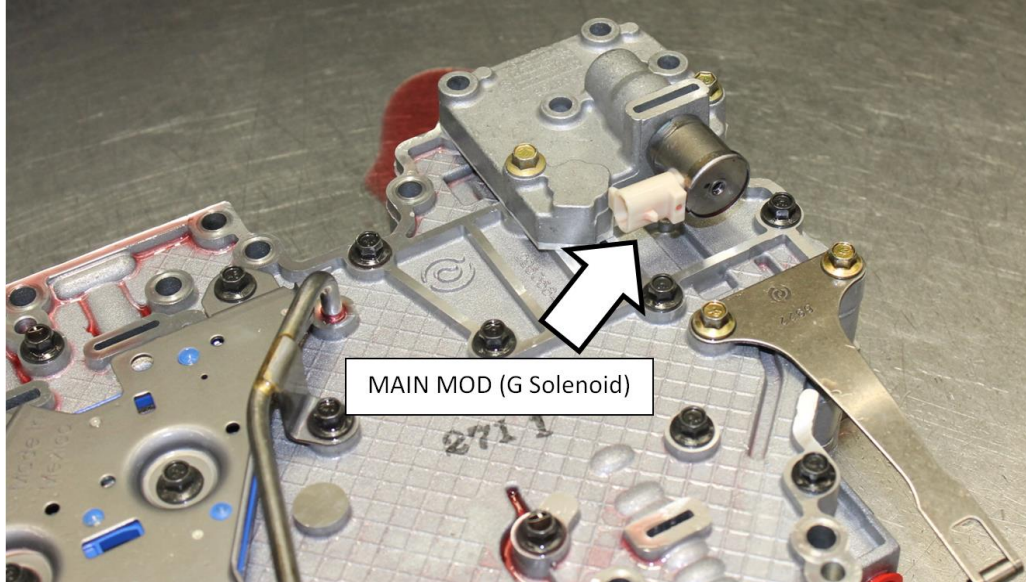
- **1030471-1030473** – 2004-2010 Allison valve bodies are supplied with four solenoids. Pressure Control A (TRIM A), Pressure Control B (TRIM B), TCC PWM and Main Mod (G Solenoid).
