Ball Joint Replacement

Part #: Ball Joint Rev. 071223

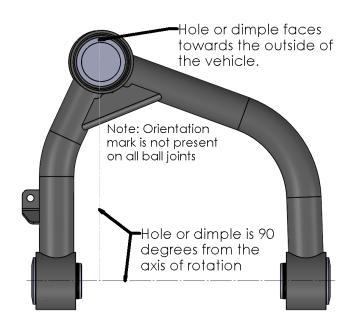
Important: Some ball joints are orientation specific. There will be a dimple or hole to indicate which direction the ball joint has more range of motion. This hole needs to face either towards the inside of the vehicle, or outside of the vehicle. Improper installation can cause premature failure.
